Manhole Inspection Summary

Manhole # S31C__018MH

Insp Date: **10/18/07 2:03 PM**

Location Address: **FRANKLIN ST**

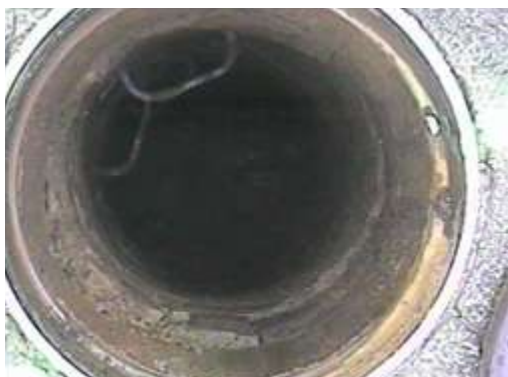
Defect 1

Offset: **1** (in.)

FRAME OFFSET

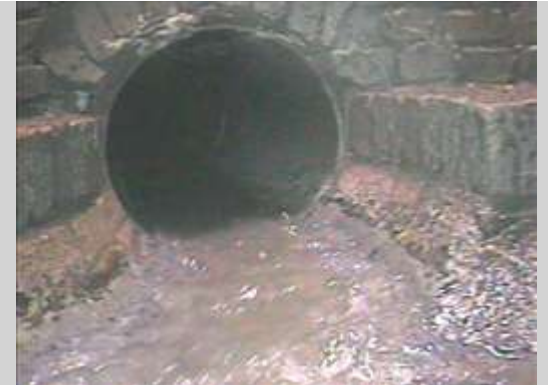
12 O'Clock Outflow

8 in. Circular Gravity Sewer
Pipe Out @ 12 O'Clock

Pipe Height: (in.) Direct
Pipe Material: **Clay** ☐ Pipe Lined
Invert Depth: **15.55** (ft.) Flow Characteristics: **Fast**
Deposits: ☒ None ☐ Mud ☐ Sludge ☐ Debris ☐ Grease
Silt Depth: (in.) Deposits Extent:
Infiltration: **None** Pipe Seal Cond: **Sound**

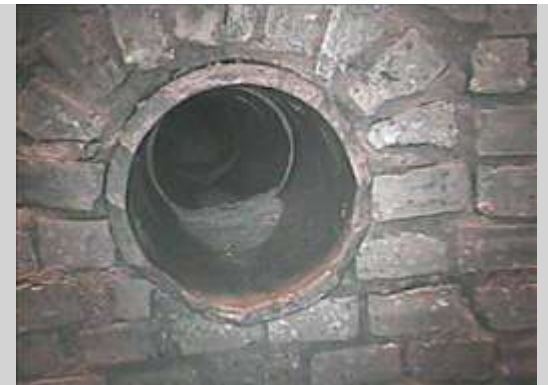
3 O'Clock Inflow

8 in. Circular Gravity Sewer
Pipe In @ 3 O'Clock

Pipe Height: (in.) Direct
Pipe Material: **Clay** ☐ Pipe Lined
Invert Depth: **10.98** (ft.) Flow Characteristics: **None**
Deposits: ☒ None ☐ Mud ☐ Sludge ☐ Debris ☐ Grease
Silt Depth: (in.) Deposits Extent:
Infiltration: **None** Pipe Seal Cond: **Sound**

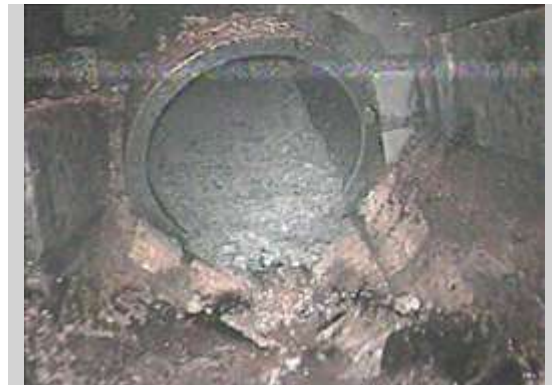
Drop In @ 3 O'Clock

Drop: **Outside Direct**
Angled: Reading: (ft.)
Inv Depth: **14.78** (ft.)
Drop Condition: **Open**

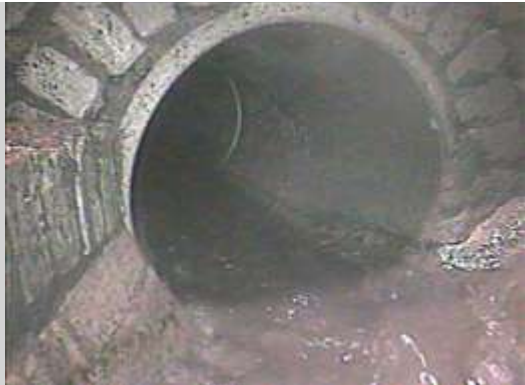
6 O'Clock Inflow

Pipe In @ 6 O'Clock

Invert Depth: **15.29** (ft.) Flow Characteristics: **Fast**

Infiltration: **None** Pipe Seal Cond: **Sound**

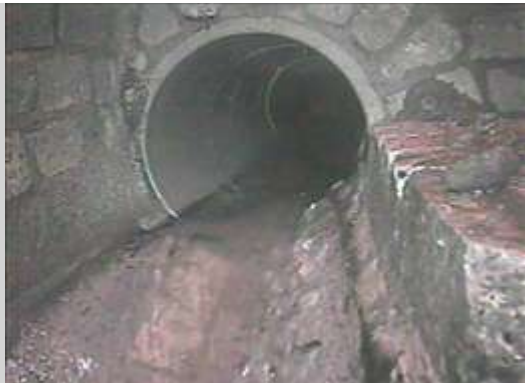
8 O'Clock Inflow

Pipe In @ 8 O'Clock

Invert Depth: **15.06** (ft.) Flow Characteristics: **Fast**

Infiltration: **None** Pipe Seal Cond: **Sound**
